SARASOTA COUNTY SCHOOL BOARD ENGLEWOOD ELEMENTARY SCHOOL

150 N. McCall Road
DEMOLITION OF BUILDING #6
CASTALDI REPORT

October 18, 2018

IX. BUILDING CONDITION SURVEY OF BUILDING #6 – ENGLEWOOD ELEMENTARY SCHOOL ENGLEWOOD, FLORIDA

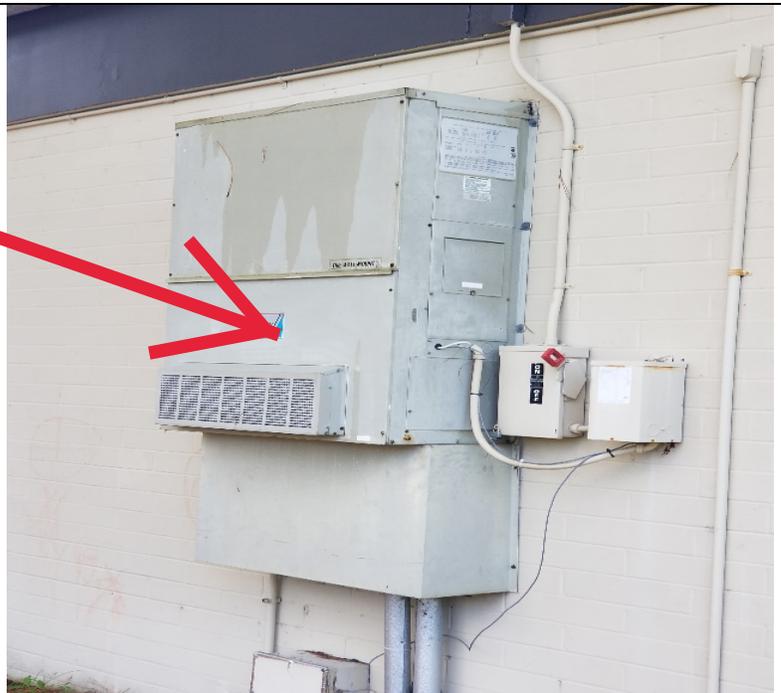
View of exterior of building.

View of exterior hvac units on walls.

Building is flush with grade. Needs to be elevated to meet Sarasota County's flood plain requirements

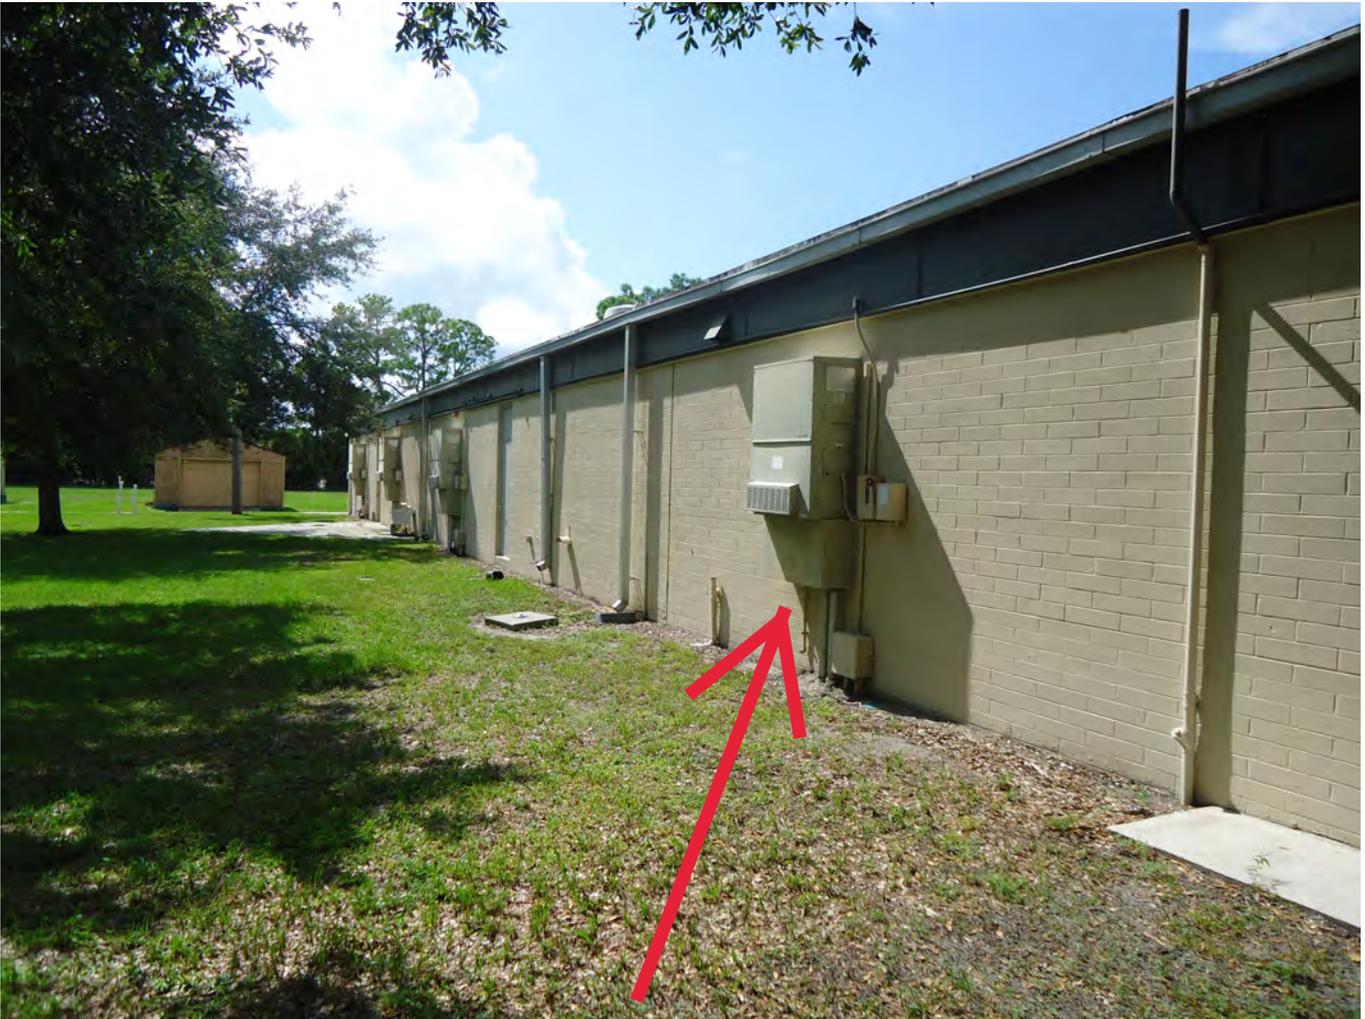
North side of Building 6 showing existing Bard A/C units, Roof mounted exhaust fan and wall cap from restroom ceiling mounted exhaust fan.

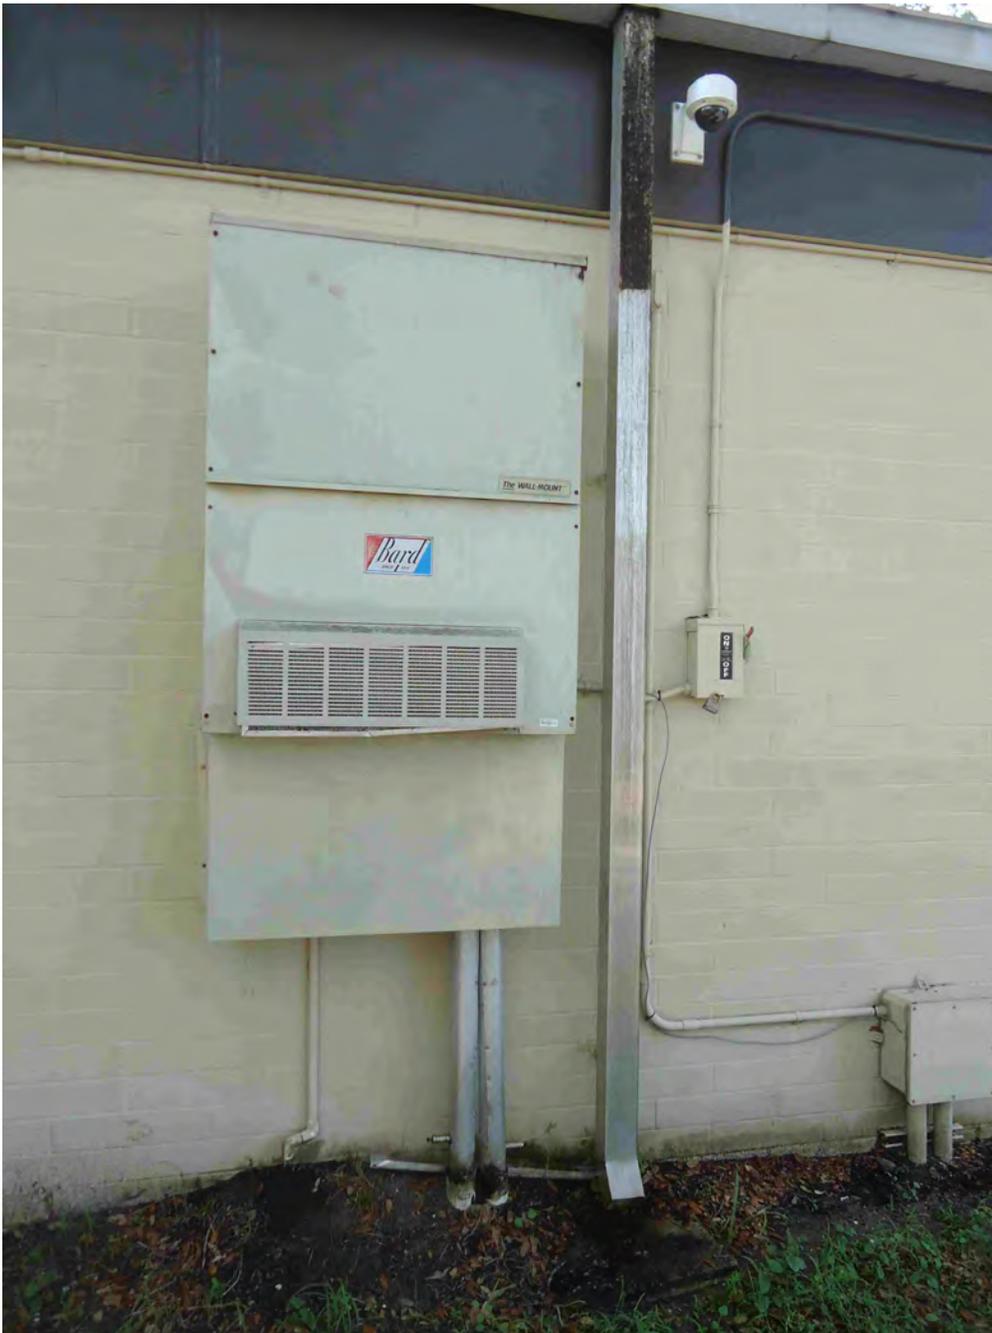
Exterior wall mounted Bard A/C unit showing damaged outdoor air intake grille and condensate drain.

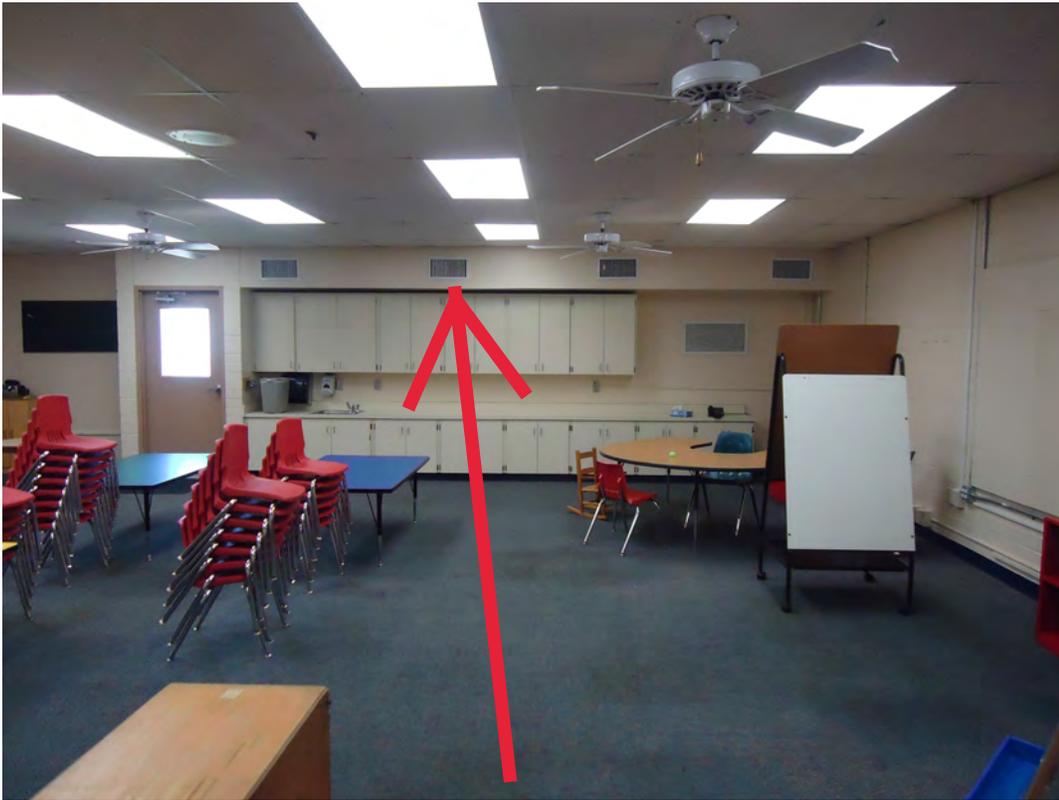
Interior view of typical classroom showing four supply registers within a soffit below the ceiling and the wall mounted return grille. Bard unit is directly behind the return grille.

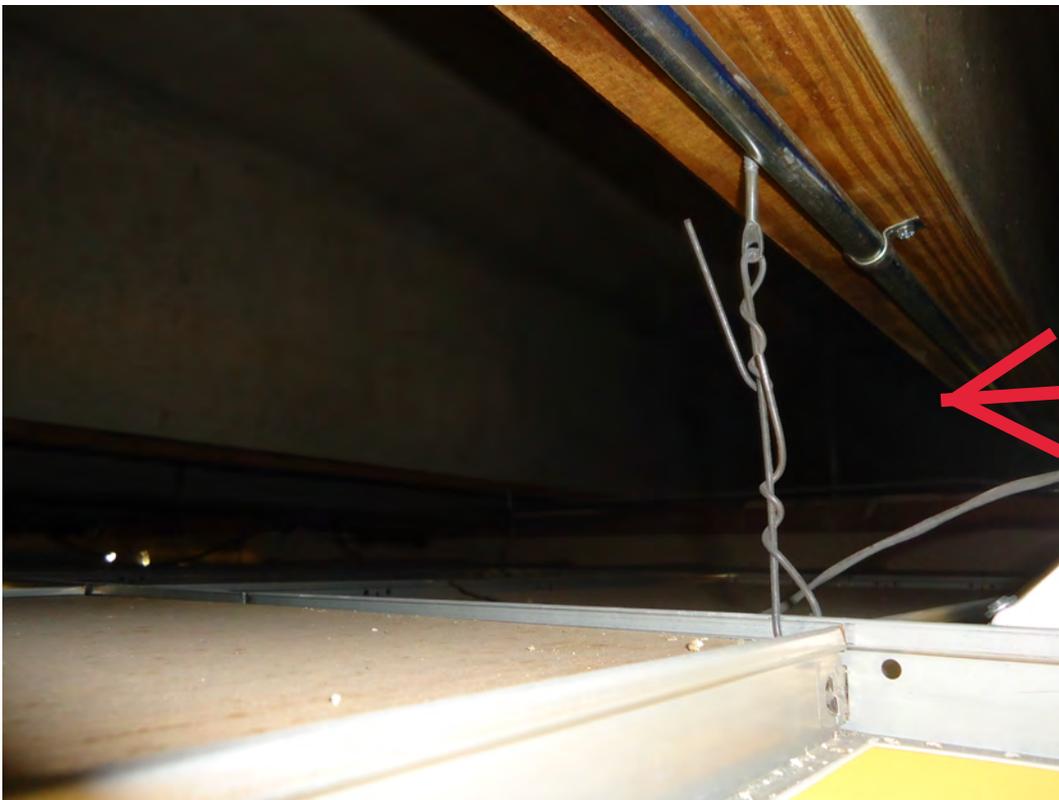
Photo shows limited space between lay in ceiling and structure.

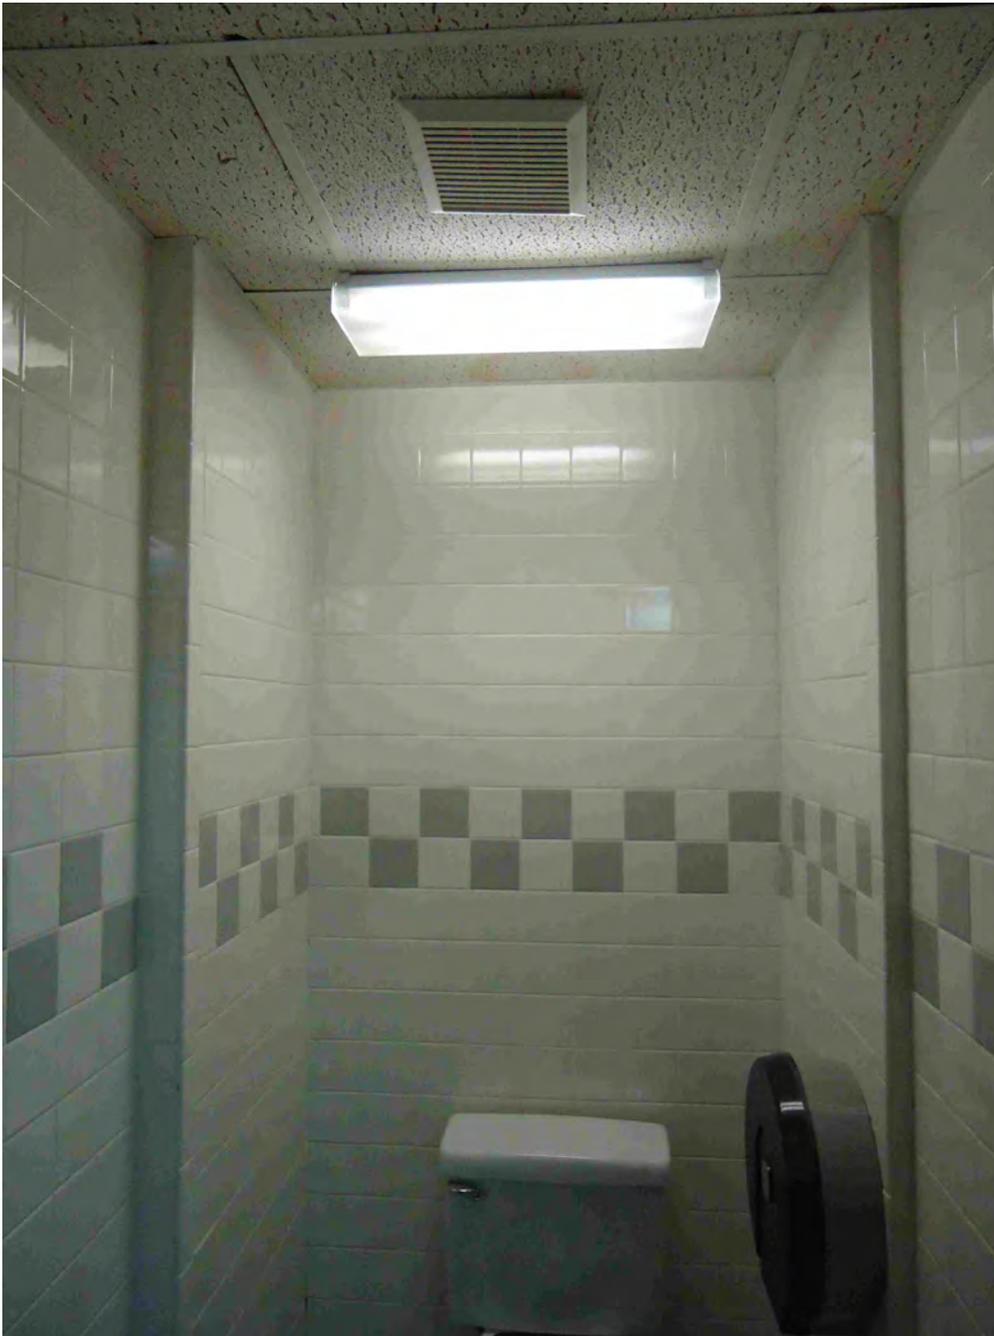
Ceiling mounted exhaust fan.

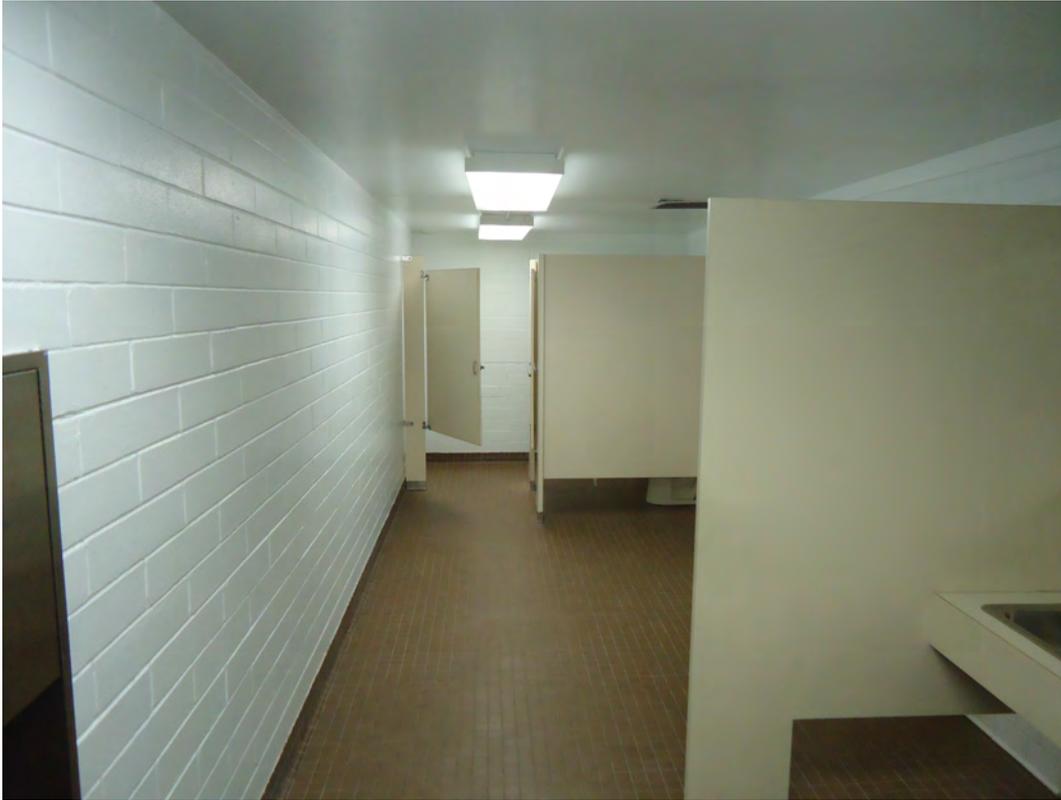
The two larger group restrooms are exhausted via a single roof mounted exhaust fan ducted to an exhaust grille in each of the two restrooms. The exhaust grilles are damaged beyond repair.

Damaged exhaust grille in group restroom.

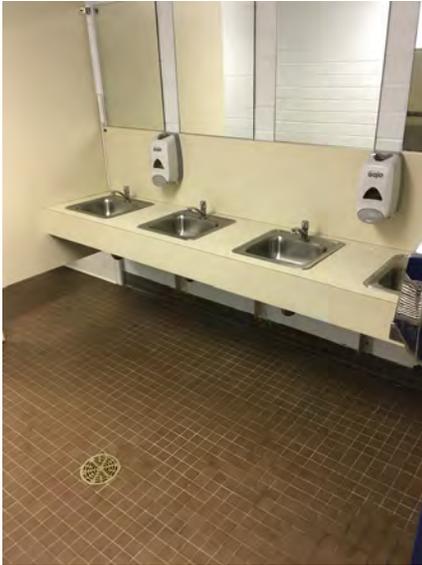
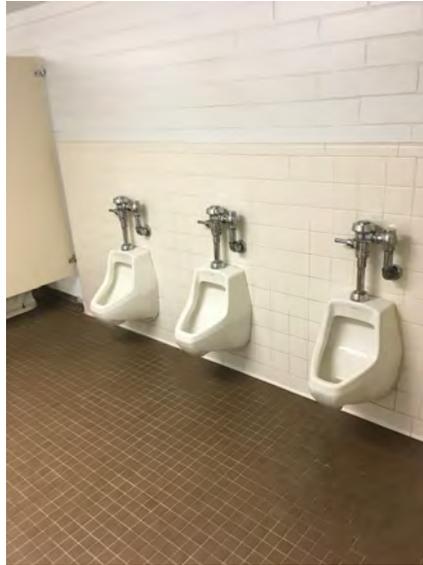
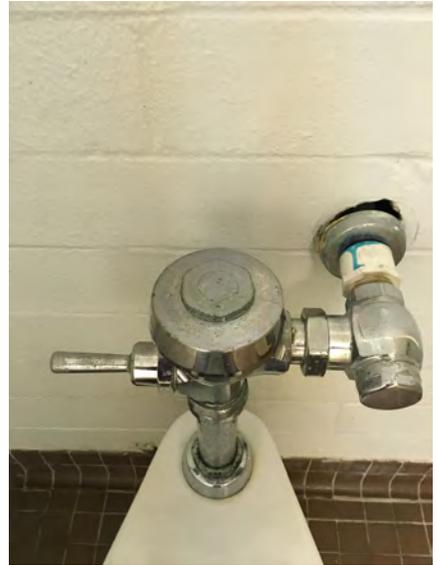
Figures 1, 2, and 3 - Condition of the fixtures in the Boy's Group Restroom. The fixtures are a mixture of white vitreous china and stainless steel. There is not a designated ADA lavatory or any protective piping covers. The lavatory faucets in this restroom are all of the metering type. There are grab rails at one of the water closets but there is not sufficient space to provide for wheel chair access or turnaround space.

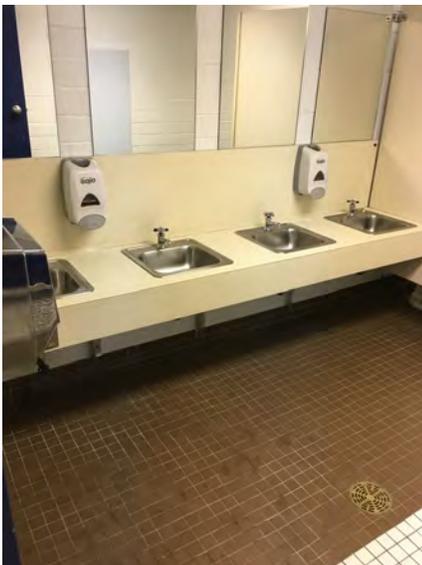
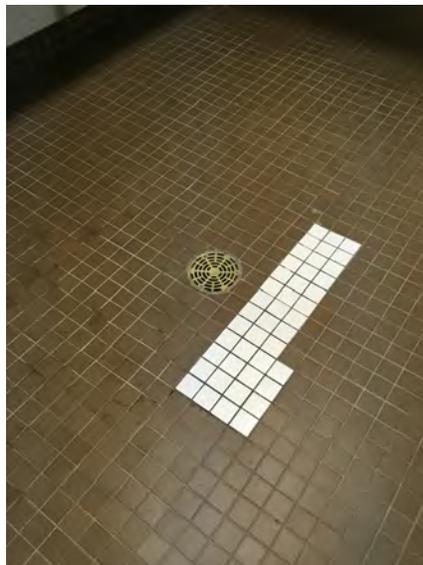
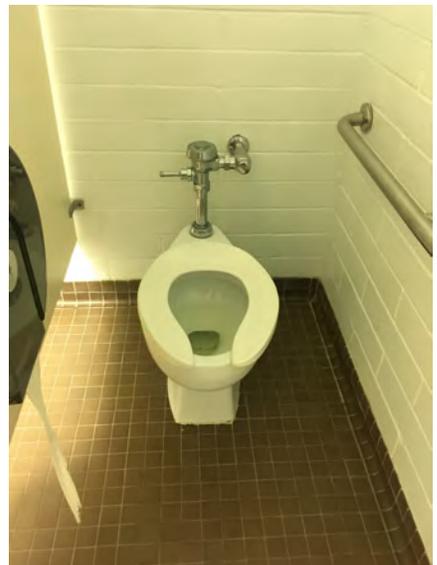
Figures 4, 5, and 6 - Condition of the fixtures in the Girl's Group Restroom. The fixtures are a mixture of white vitreous china and stainless steel. There is not a designated ADA lavatory or any protective piping covers. The lavatory faucets in this restroom do not appear to be ADA compliant. There are grab rails at one of the water closets but there is not sufficient space to provide for wheel chair access or turnaround space. There also appears to have been a floor repair at the floor drain that could potentially be related to drainage.

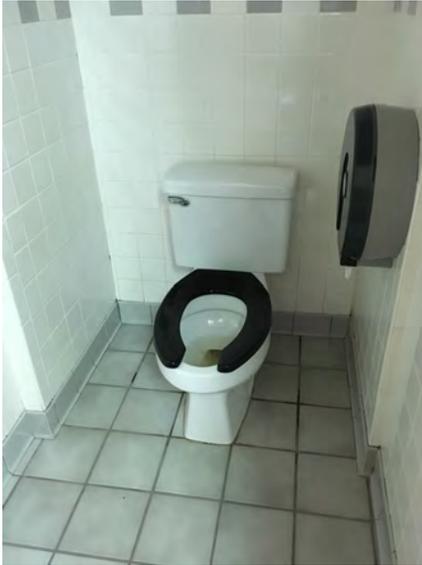
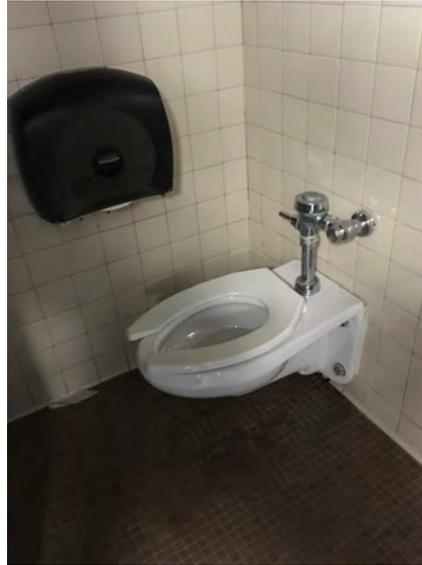
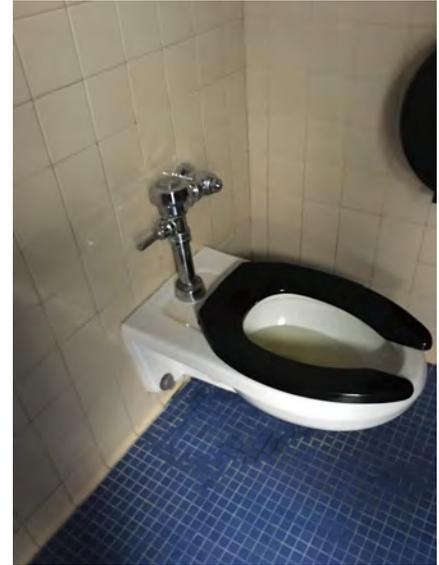
Figures 7, 8, and 9 - These photos show the typical condition of the primary classroom unisex restroom water closets. There are no grab rails or wheelchair access. Figure 8 shows the flush handle to the far side of the water closet away from the access. There is a mixture of flush valves, flush tanks, wall mount water closets, and floor mount water closets. Figure 9 shows potential signs of leakage.

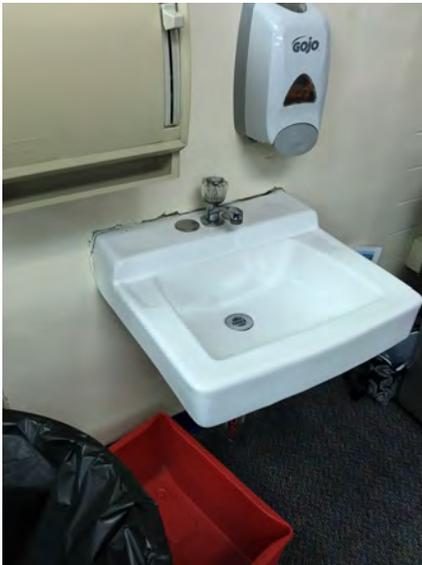
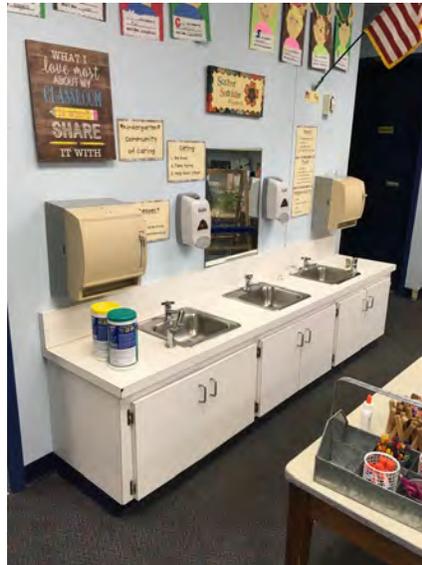
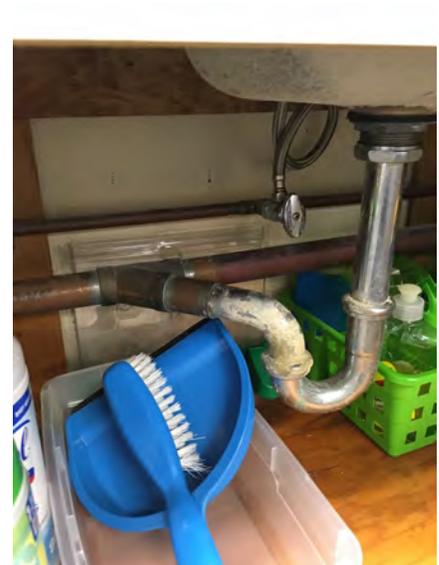
Figures 10, 11, and 12 - These photos show the typical condition of the primary classroom sinks. The wall mount lavatory is mounted outside the primary classroom unisex restrooms, it does not allow for ADA access and there are no protective piping covers installed. The faucet also does not meet ADA requirements. The classroom sinks are typical of the primary classrooms and do not appear to meet ADA requirements. The photo of the below counter piping shows the mixture of piping materials with apparent galvanic corrosion caused by dissimilar metals.

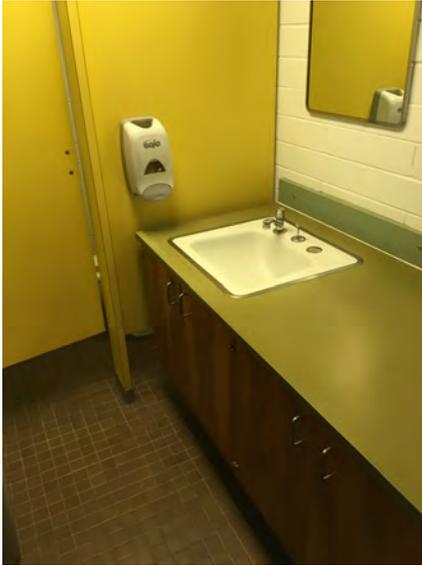
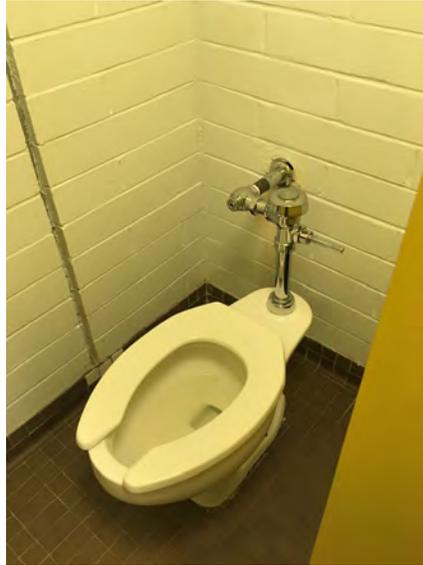
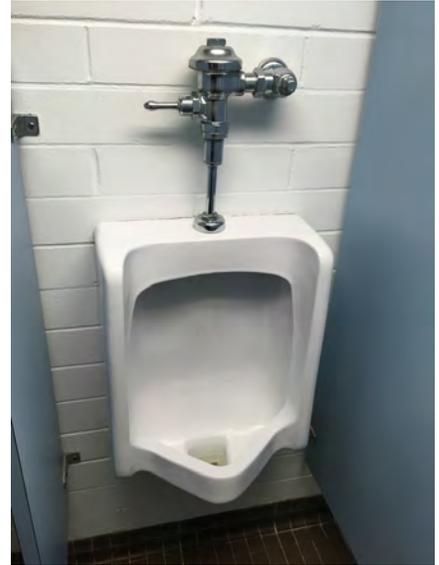
Figures 13, 14, and 15 - These photos show the typical condition of the staff restrooms. Again, none of the fixtures in either the Women's or the Men's staff restrooms appear to be compliant with current ADA requirements, nor does there appear to be space to address ADA clearance issues.

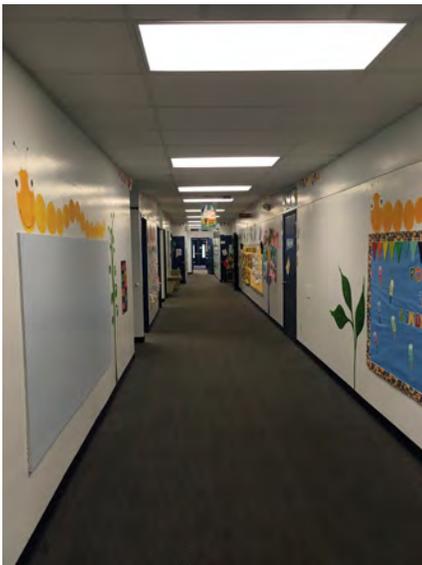
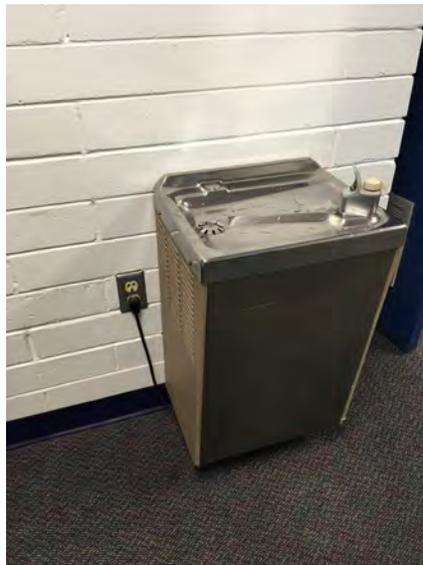
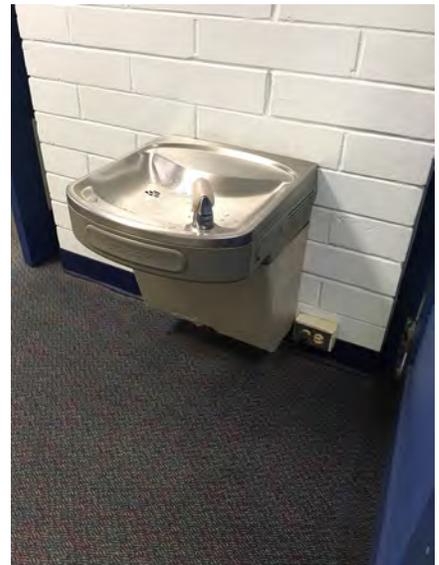
Figures 16, 17, and 18 - These photos show the locations of the two interior electric water coolers and their condition. The casing on both units show signs of rusting and deterioration.

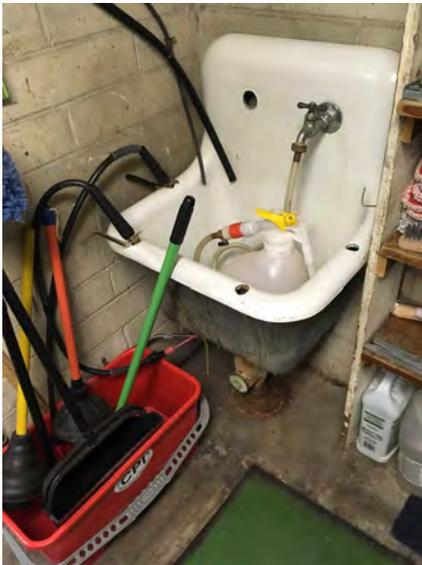
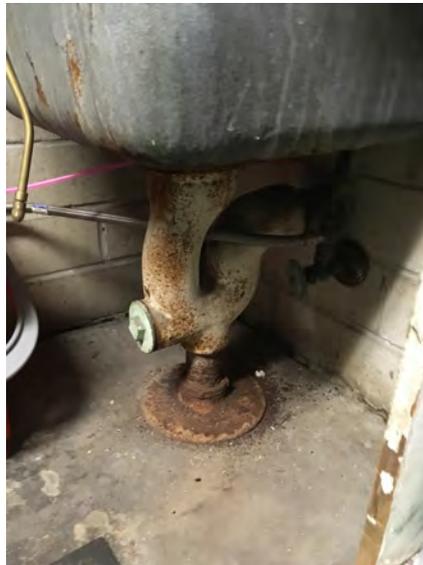
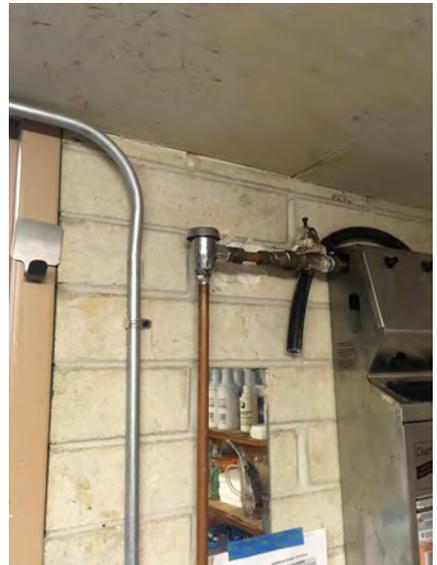
Figures 19, 20, and 21 - These photos show the fixtures and piping within Janitor's Closet 019. The service sink is an older style cast iron wall mounted unit and is provided with cold water only. There is also some exposed cold water piping that was installed to serve a cleaning solution station. The vacuum relief valve provided at the unit is badly corroded as shown in the photo.

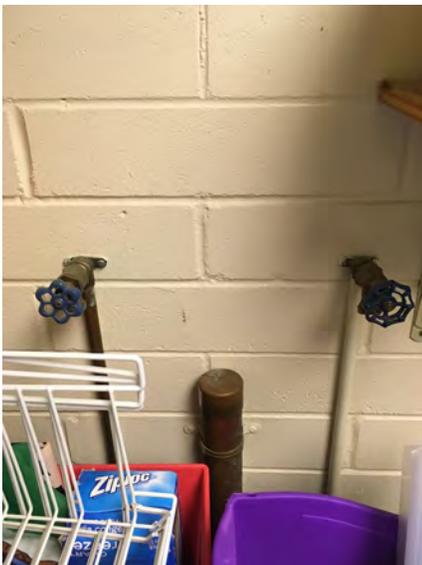
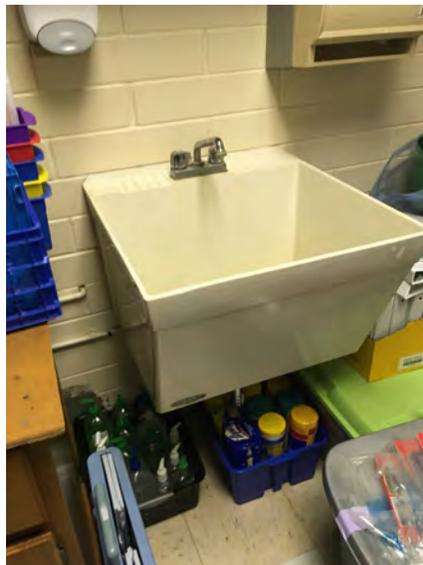
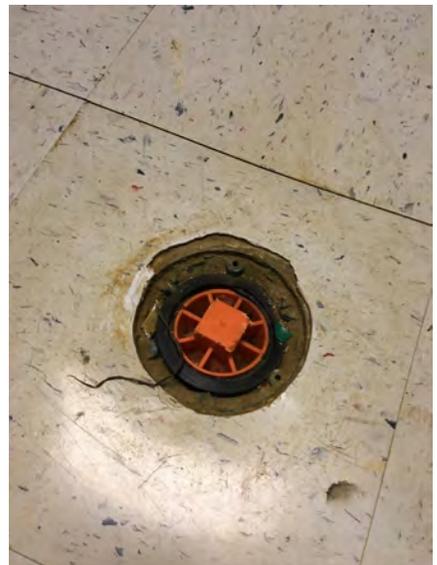
Figures 19, 20, and 21 - These photos show the fixtures and piping within a small utility closet off of Classroom 004. There are a set of washing machine hook-ups. Although there appears to be a hot and cold water supply at this location, we did not determine a hot water source. There is a wall mounted molded thermoplastic utility sink provided with cold water only, the utility sink appearing to be in fair condition. There is a floor cleanout located in this room that has a history of sanitary waste line stop-ups and overflows according to the building occupants. The cleanout plug was not removed during the site visit.

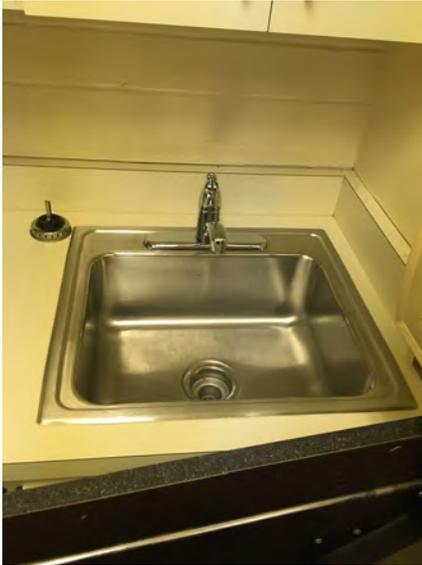
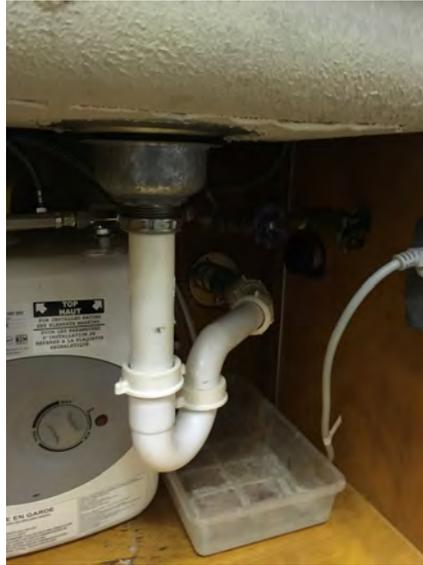
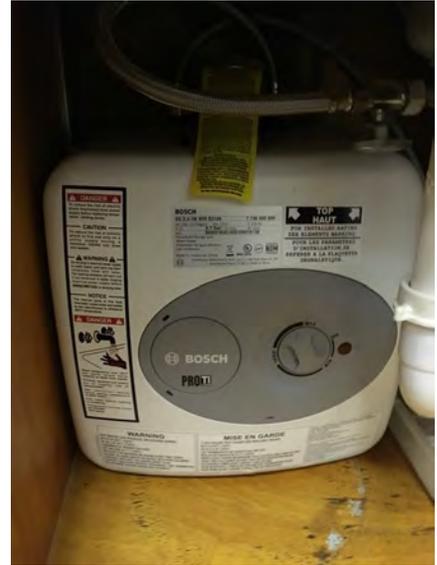
Figures 22, 23, and 24 - These photos show the sink and water heater installed in Room 005B. The sink is a stainless steel countertop model with a single handle faucet. The water heater is a Bosch Model ES 2.5-1M WIR S3100. The water heater is a 2.7 gallon unit with a single 1,440 watt heating element. Both the water heater and sink are in good condition.

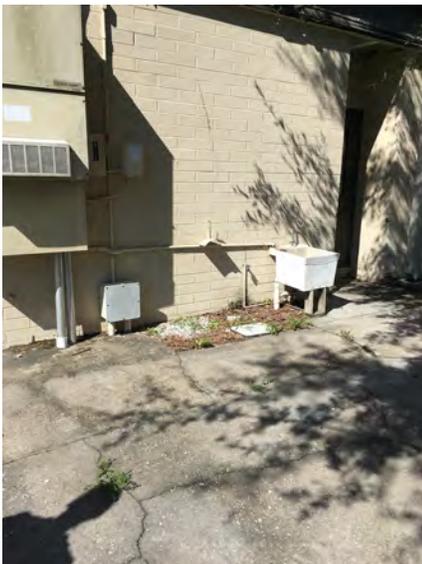
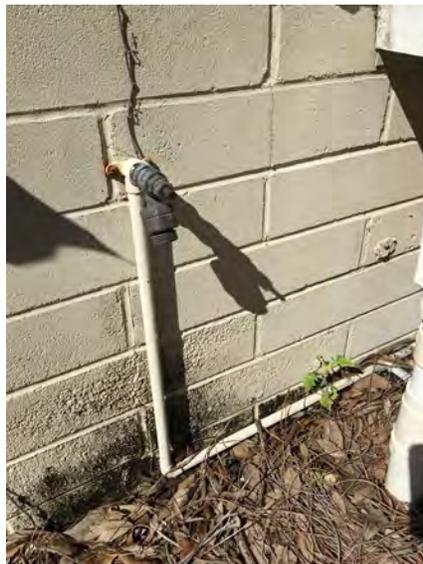
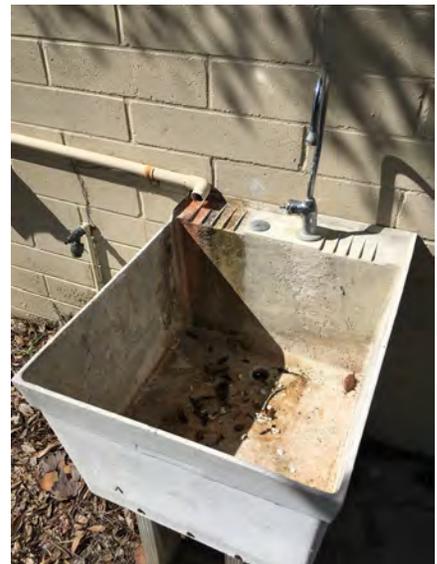
Figures 25, 26, and 27 - These photos show the exterior utility sink installation and condition. The piping for both domestic water and sanitary waste and vent is pvc and is exposed to the elements and to damage. The sink is in poor condition and is used as a receptacle for condensate from the adjacent wall mounted A/C unit. There is a hose bib located near the sink which is also served by exposed pvc piping. The sink is vented by an air admittance valve located next to the sink.

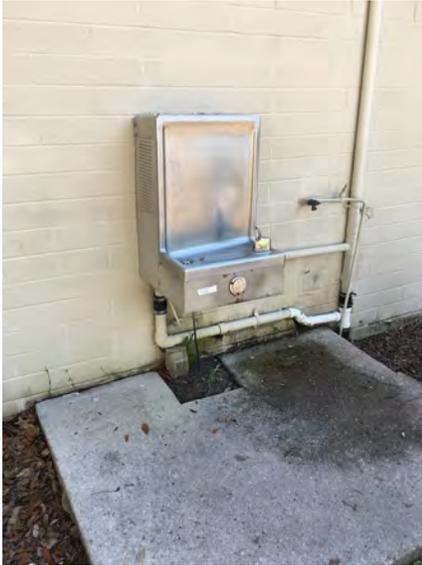
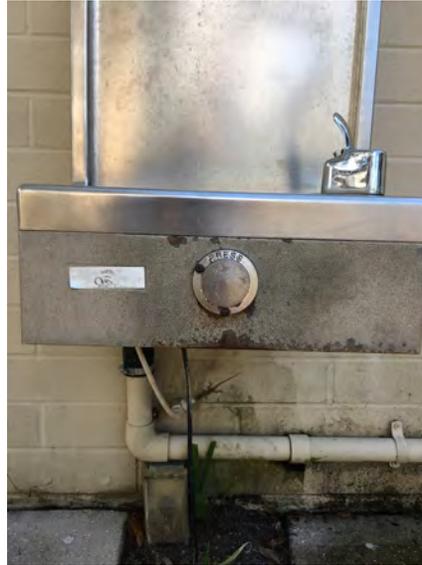
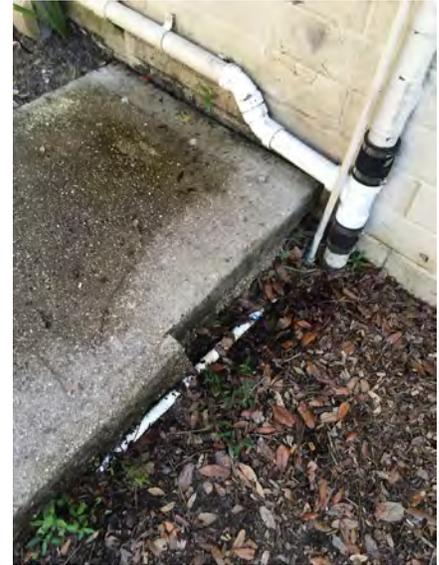
Figures 28, 29, and 30 - These photos show the exterior drinking fountain installation and condition. The piping for both domestic water and sanitary waste and vent is pvc and is exposed to the elements and to damage. There does not appear to be a trap installed for the drinking fountain. The fountain case shows signs of rusting and deterioration. There is a domestic water line that serves an adjacent hose bib. The domestic water line is exposed at grade and subject to damage. The waste piping shows signs of recent repair.

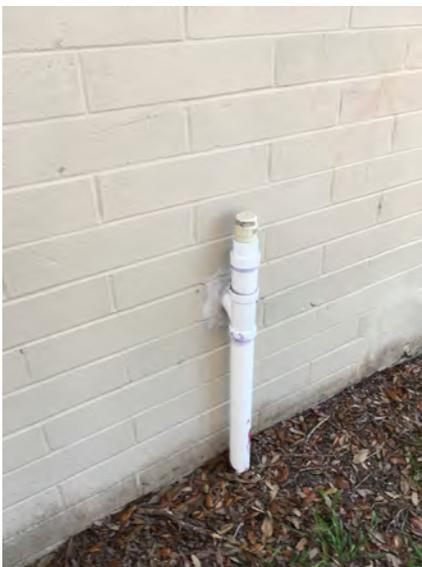
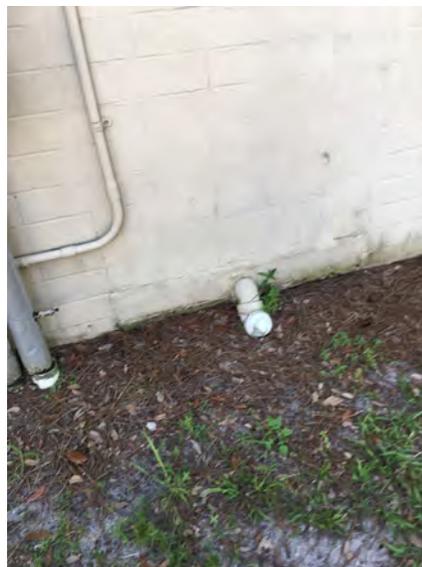
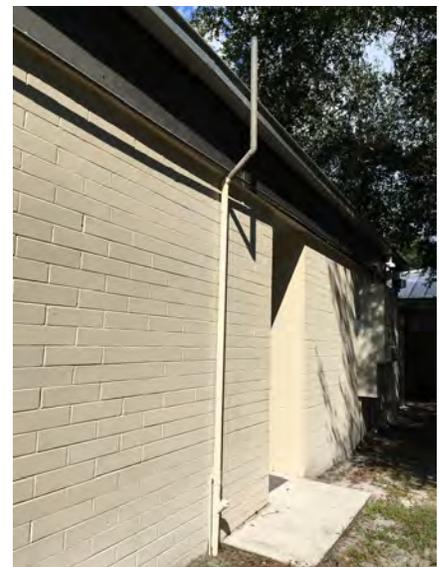
Figures 31, 32, and 33 - These photos show typical external waste and vent piping that was installed to serve fixtures added in renovations subsequent to the building's original construction. There are several locations where exterior pvc waste piping was added to serve miscellaneous sinks inside the building with venting being done with air admittance valves. The pvc piping is exposed to weather and the elements and is subject to degradation and damage.

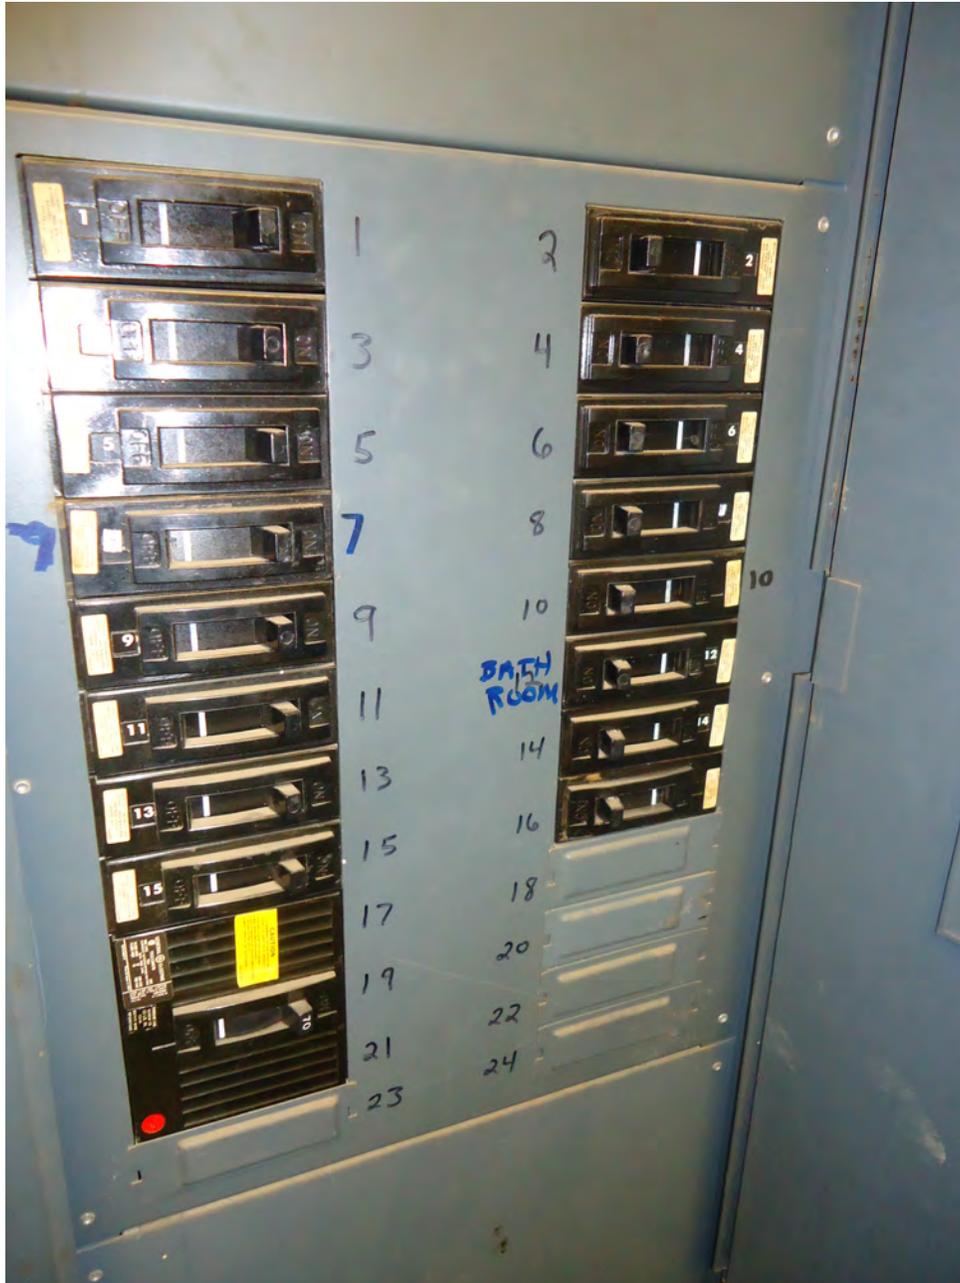
The existing building power system is a 400 ampere, 480/277V three phase power system with the electrical feeder originating from the campus main service electrical room (to the east of the chiller plant). The existing electrical gear is manufactured by General Electric and was installed as part of the original construction. Spare parts are beginning to be phased out by the manufacturer and are becoming increasingly more expensive and rare.

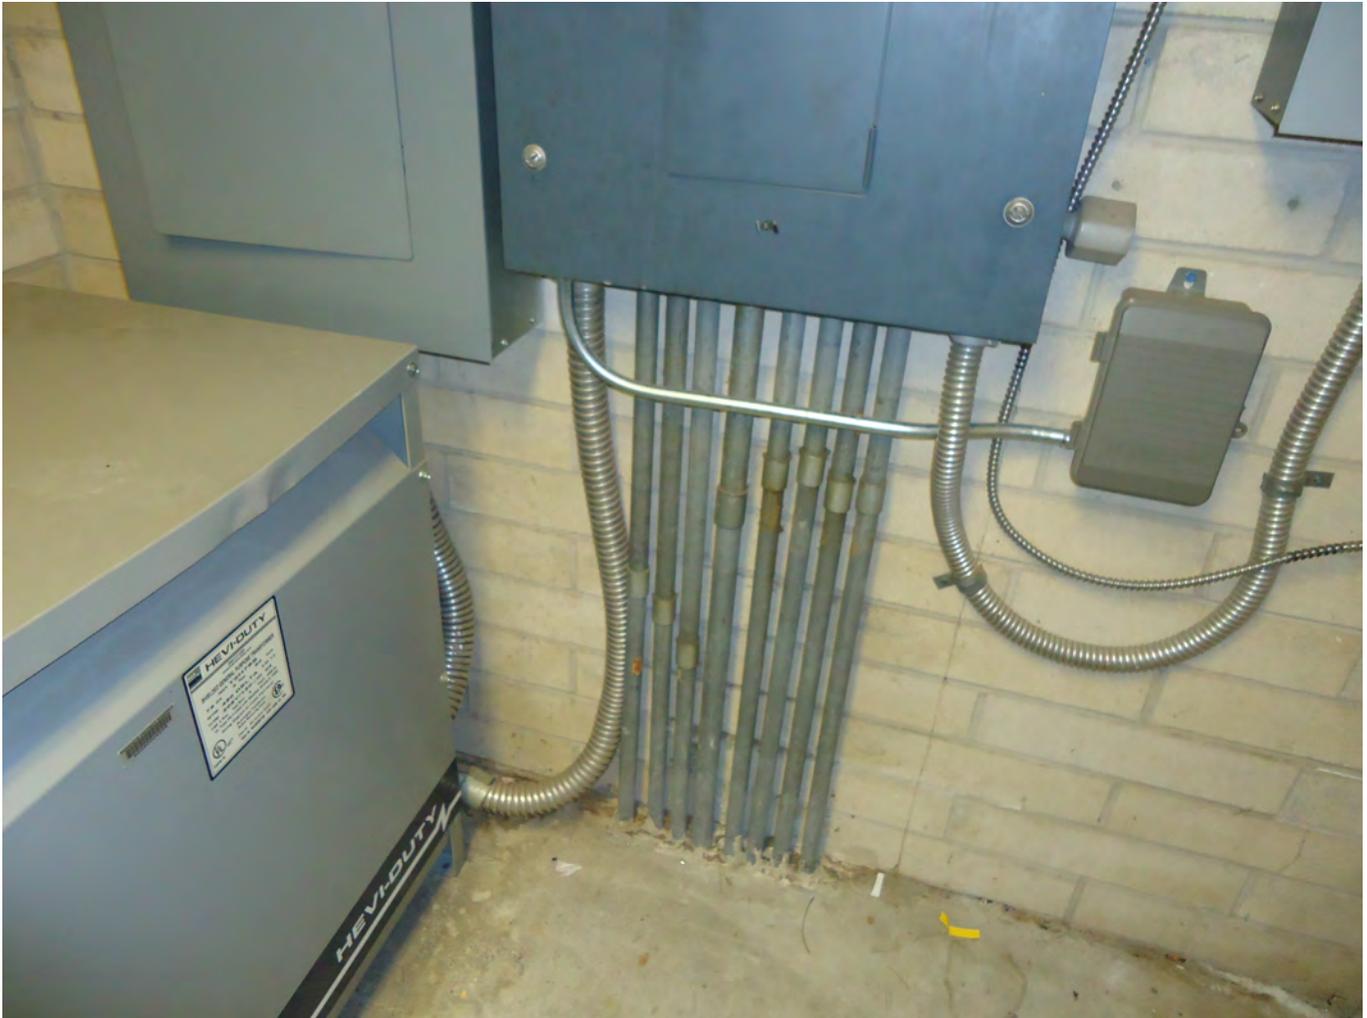
The existing electrical gear is currently installed in a custodial closet with limited space. The existing configuration of the electrical gear is not code compliant with regards to working clearances and working space. The lack of working clearances and working space has a direct bearing on the potential safety of facilities personnel when operating and maintaining the existing electrical gear.

According to the best information available to the industry, electrical panelboards expected life is approximately 30 years. Therefore, the existing electrical gear is currently approaching 50% more than would typically be expected.

None of the existing electrical gear is protected with a surge protection devices (SPD) as is typical of recommended standard industry practice. SPDs are recommended in this area of the state due to the frequency and intensity of lightning events.

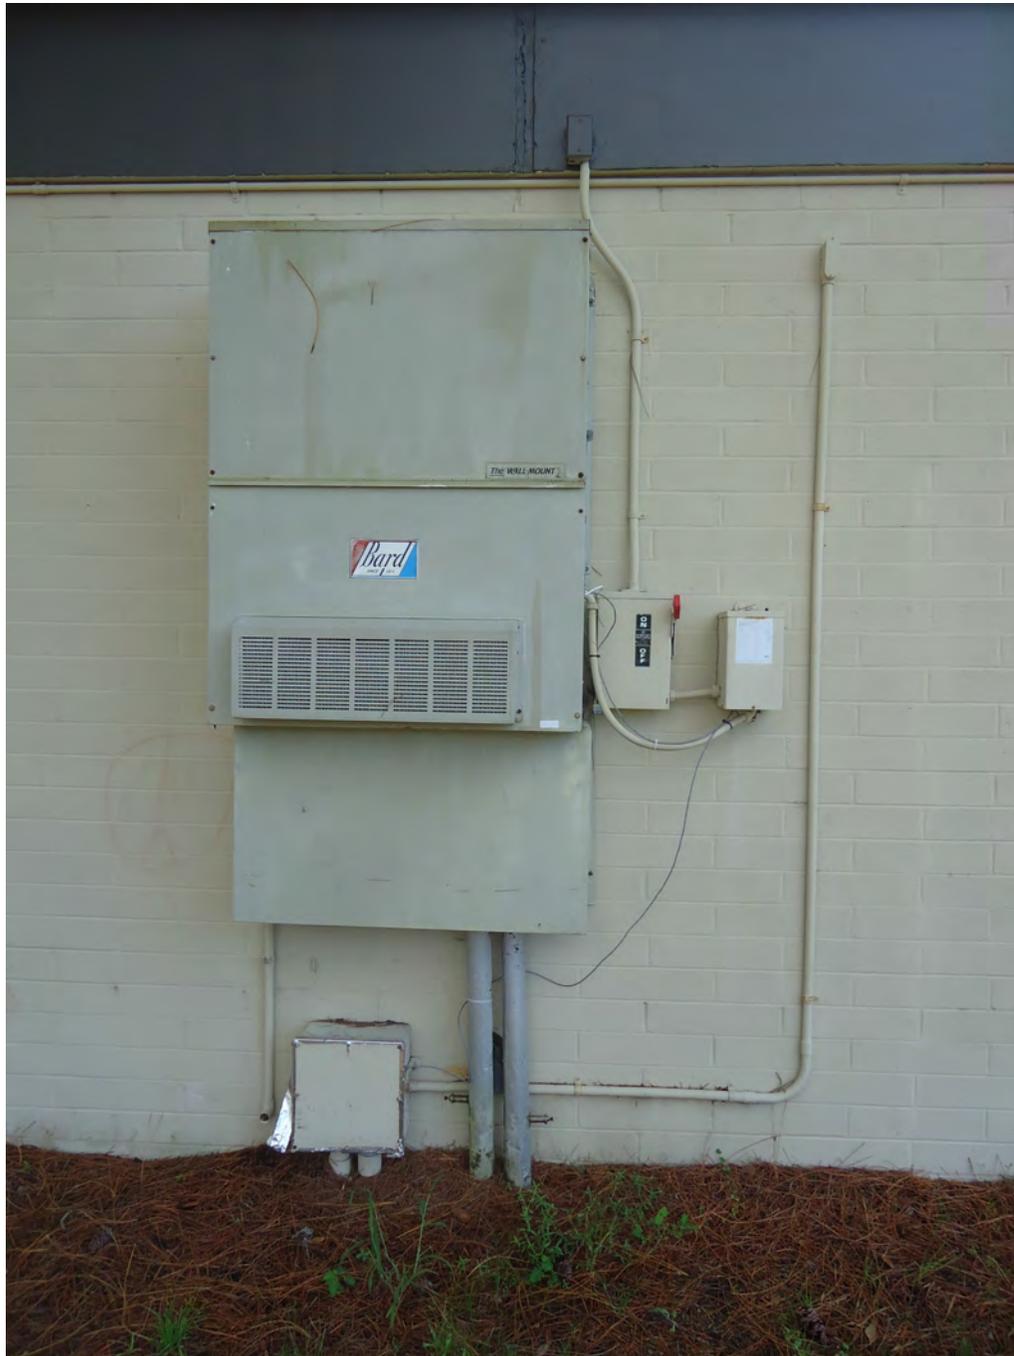
The existing branch circuits that serve the existing BARD mechanical units have buck transformers (shown to the right of the safety switch in the image below) in order to transform the voltage from a source voltage of 277V single phase to the unit voltage of 208V single phase (branch circuit breakers are three pole). While this arrangement is code compliant, it is inefficient from an electrical standpoint and introduces a potential failure point within the building power system. In addition, at single phase, the available capacity to serve a larger electric strip heat is reduced.
