SARASOTA COUNTY SCHOOL BOARD ENGLEWOOD ELEMENTARY SCHOOL

150 N. McCall Road
DEMOLITION OF BUILDING #6
CASTALDI REPORT

October 18, 2018

IX. BUILDING CONDITION SURVEY OF BUILDING #6 – ENGLEWOOD ELEMENTARY SCHOOL ENGLEWOOD, FLORIDA

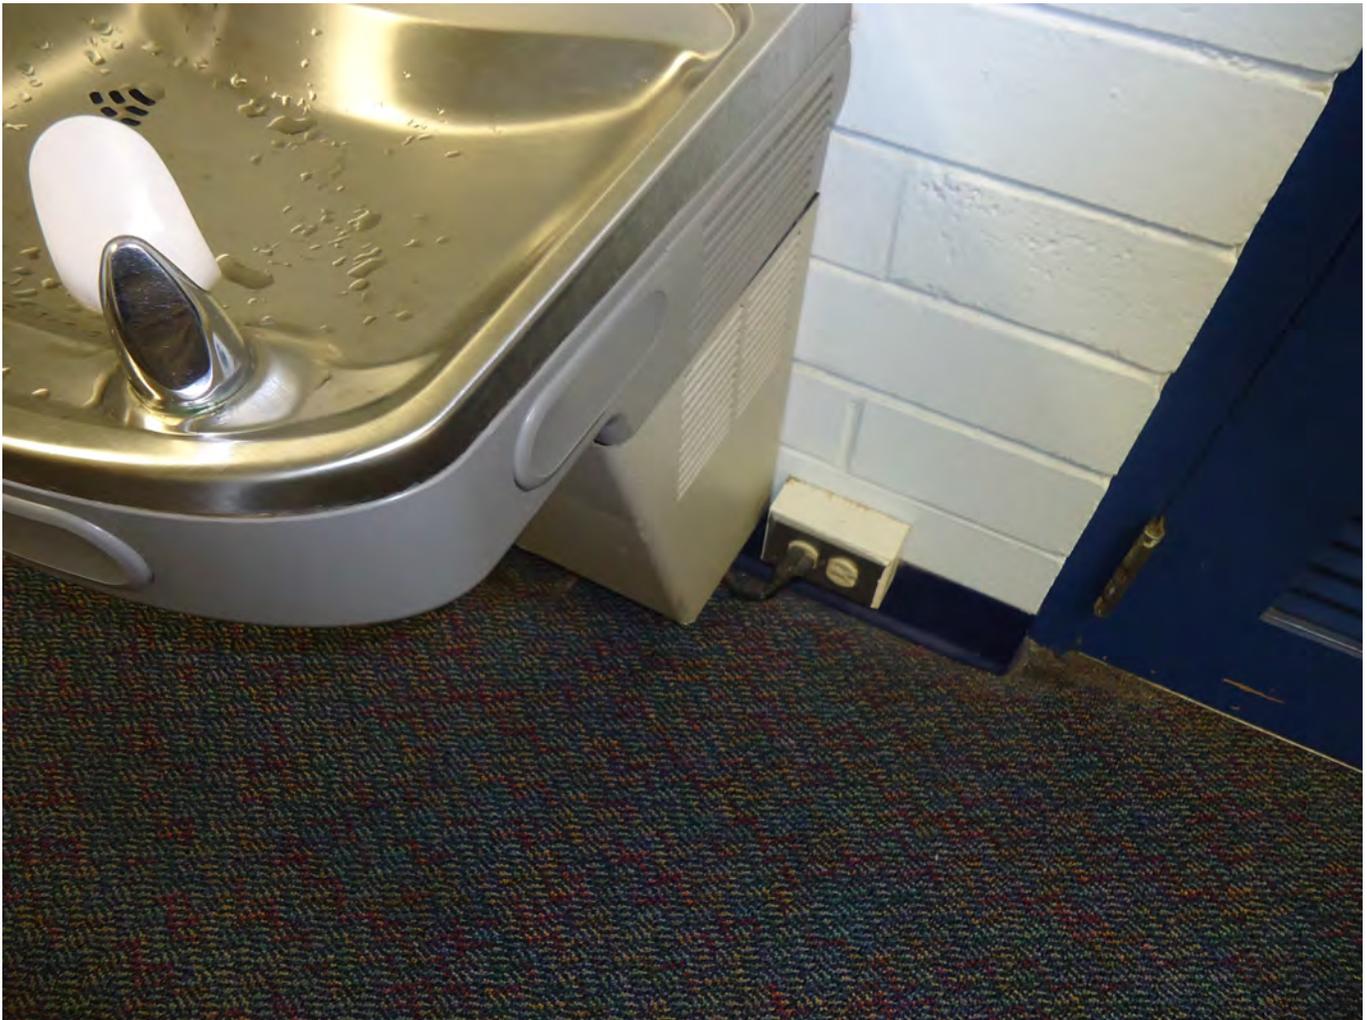
INTERIOR POWER SYSTEM (CONVENIENCE RECEPTACLES) (Overall grade assigned by the Engineer is POOR due to safety concerns)

The existing classrooms have existing branch circuits with convenience power as was typical for an elementary school without the enhanced level of technology typically found in the majority of school in Sarasota County. Many of the convenience receptacles are not ground fault circuit interrupter (GFCI) type which are now required by code for greater student and staff safety and protection.

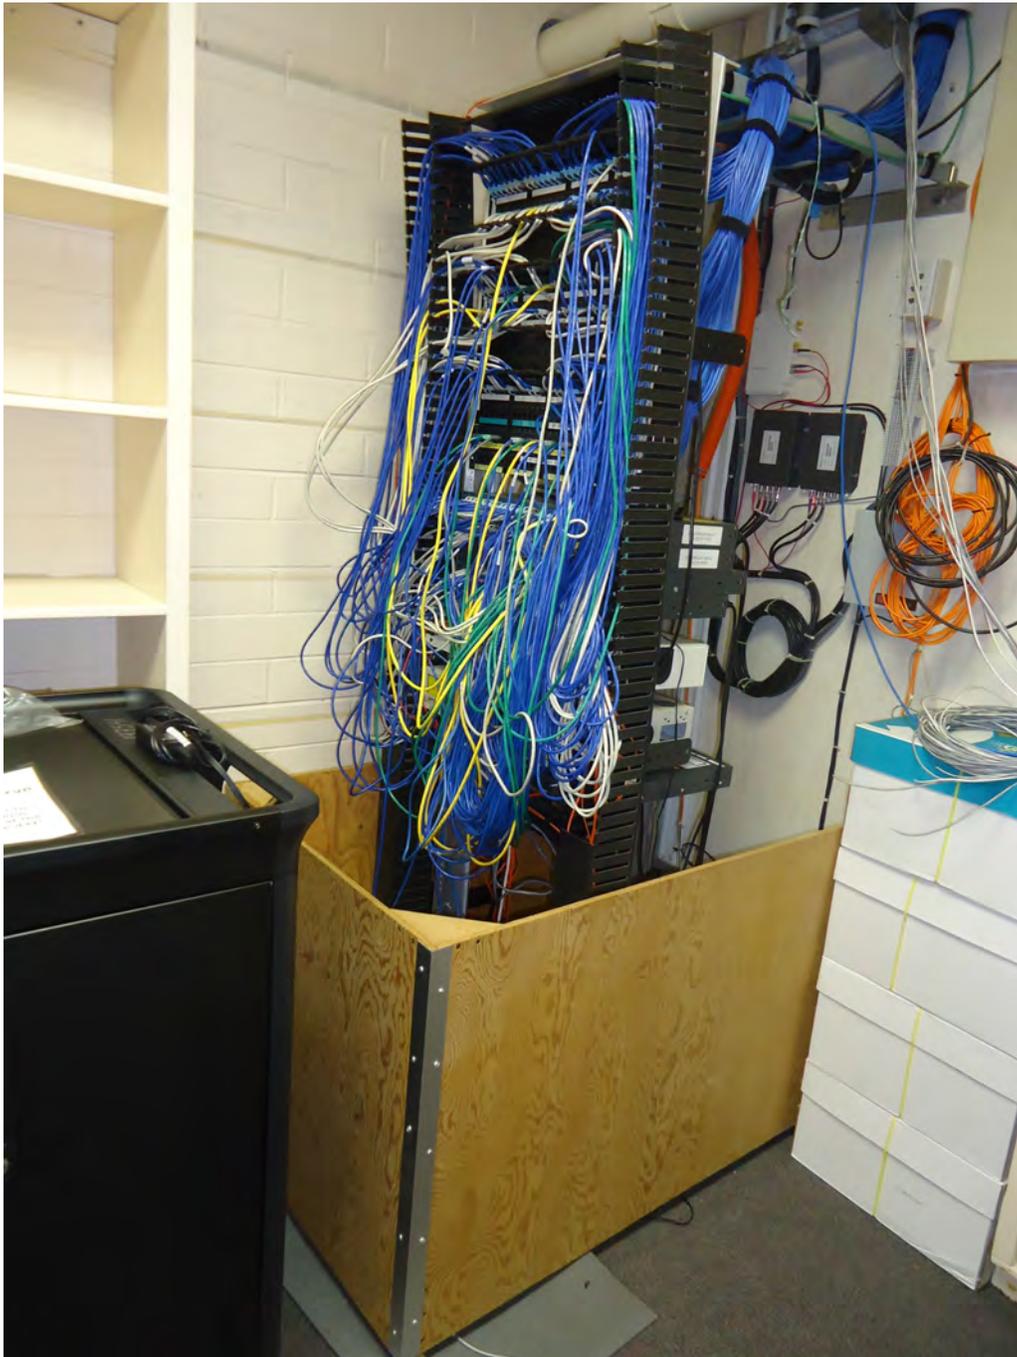
TECHNOLOGY SYSTEMS INFRASTRUCTURE (Overall grade assigned by the Engineer is POOR due to potential lack of service continuity)

An intermediate distribution frame (IDF) footprint has been ‘carved’ out of a book storage space in order to provide technology services to this building. In order to maintain the continuity of the technology services to this building, a floor mounted wooden partition was constructed to reduce the likelihood that staff would accidentally run book carts, laptop carts, paper boxes, etc. into the technology rack as shown below. In order to increase the likelihood of continuity for technology services, a dedicated space for technology and security services should be considered.

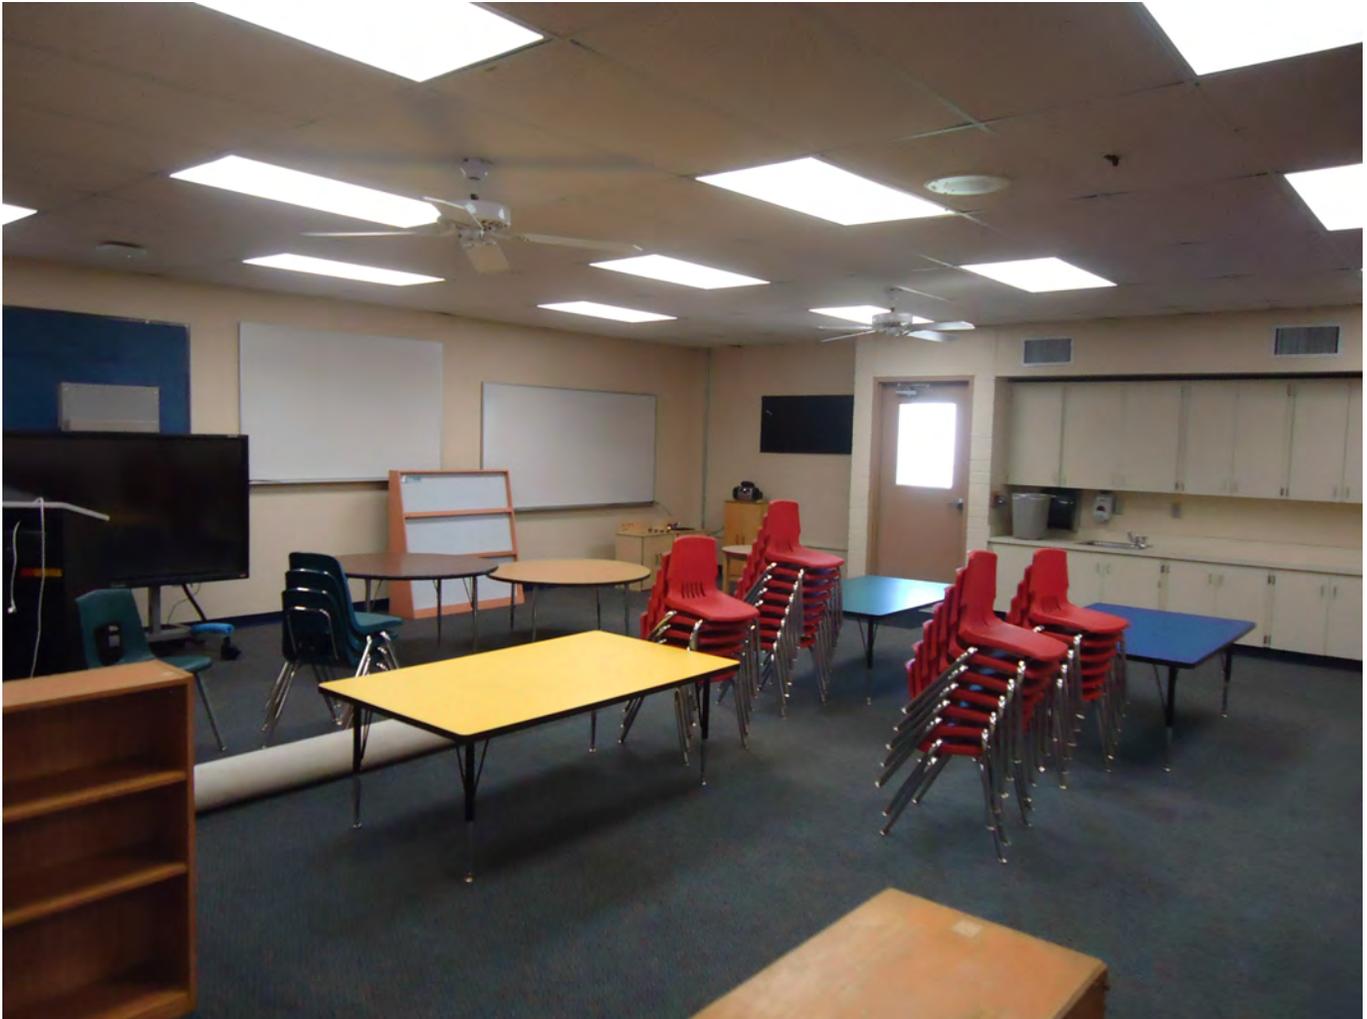
INTERIOR LIGHTING (Overall grade assigned by the Engineer is POOR due to what appears to be excessive glare in a learning environment and deficient emergency egress lighting)

The majority of the existing lighting is 2 by 4 recessed mounted fixtures with fluorescent lamps. The lighting levels appear to be satisfactory.

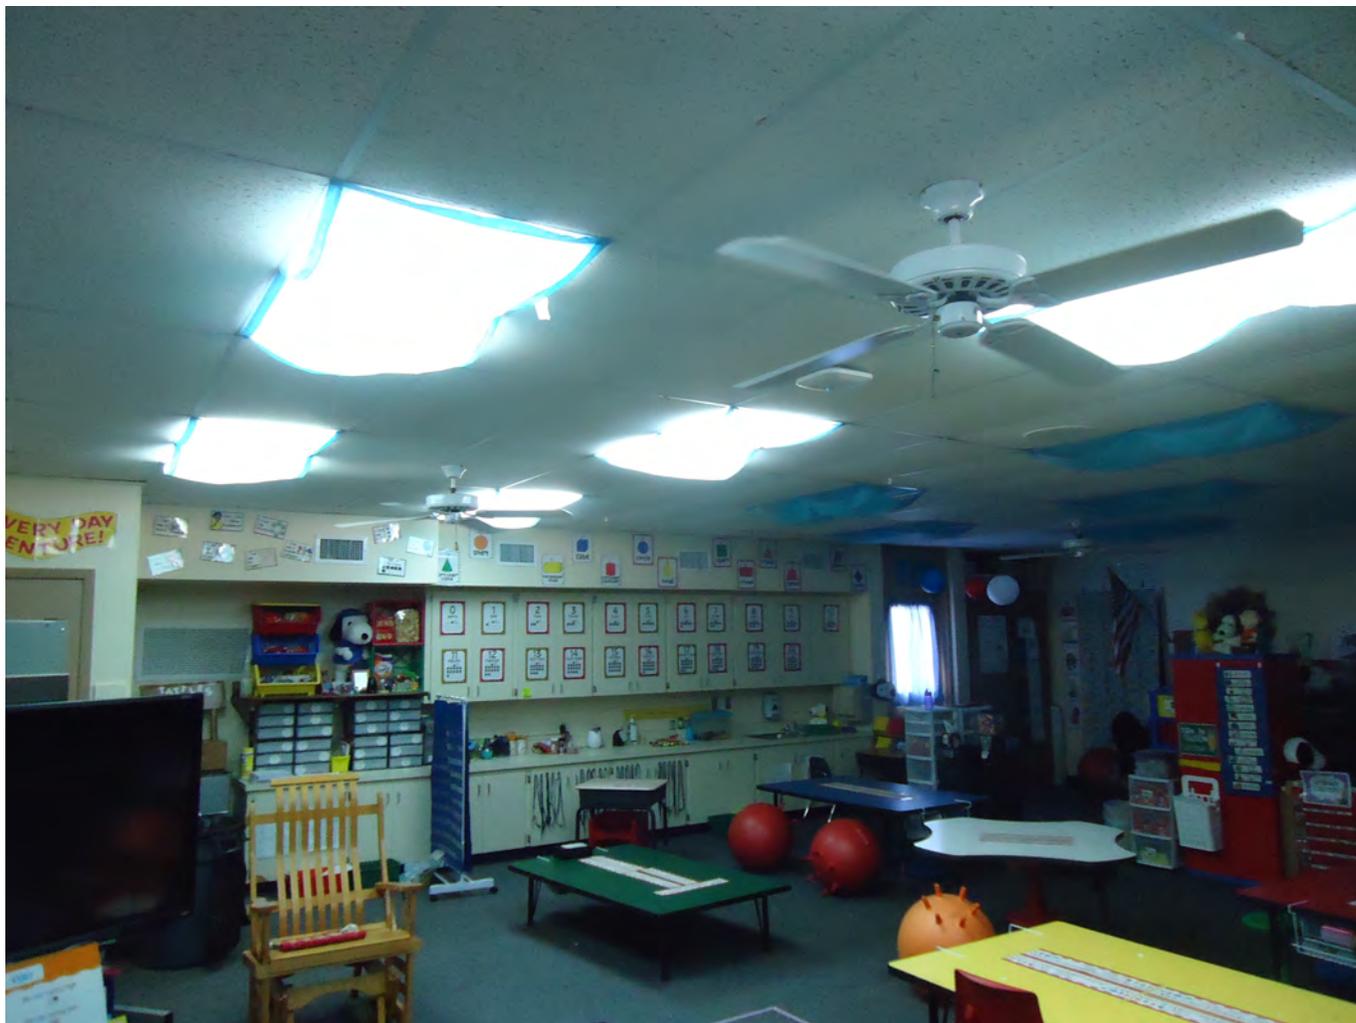
However, partially due to how fluorescent lamps change their color temperature over time as they degrade, sometimes the instructional staff must reduce unwanted glare with “expedient” methods to include adding filters to the existing fixture lenses as shown below.

Unfortunately, these “filters” also reduce the aggregate lighting levels below those minimums required by the building code. In addition, the energy efficiency of the overall building is much higher than would be found in a school building designed to the current energy code.

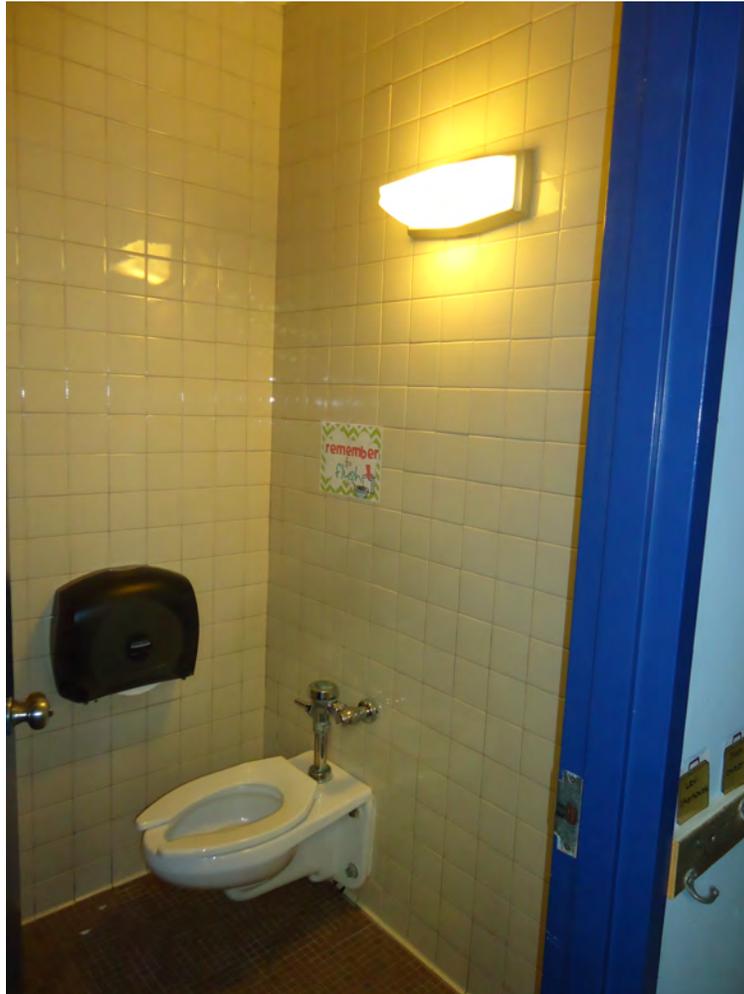
In addition, the existing toilet rooms contain fixtures that at the time the school was constructed would be able to fit (dimensionally) in the small toilet rooms. These fixtures, as shown below also contribute to glare and are not recommended for a learning environment by current design standards.

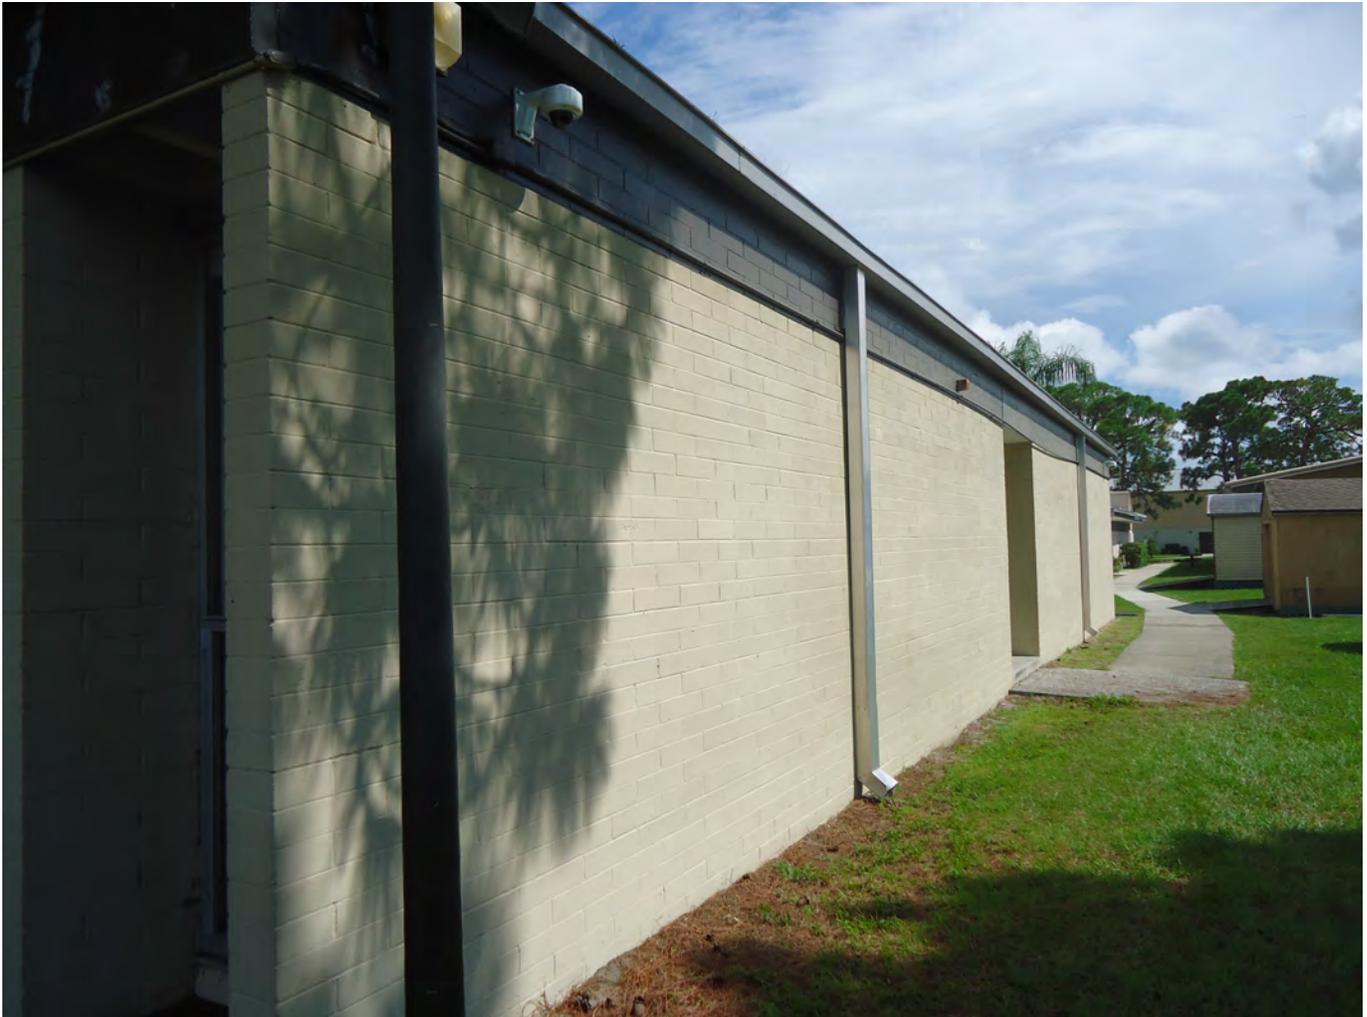
EXTERIOR LIGHTING (Overall grade assigned by the Engineer is POOR due to lack of fixtures)

The existing exterior lighting around the building appears to be deficient with little or no lighting at each exit from the building. The walkways immediately adjacent to the building have little or no lighting and appear to be deficient with no apparent pathway lighting. Current district requirements and standards require security lighting.
